Manhole Inspection Summary

Manhole # S41AA_013MH

Insp Date: **8/7/08 10:49 AM**

Location Address: **1516 e madison st**

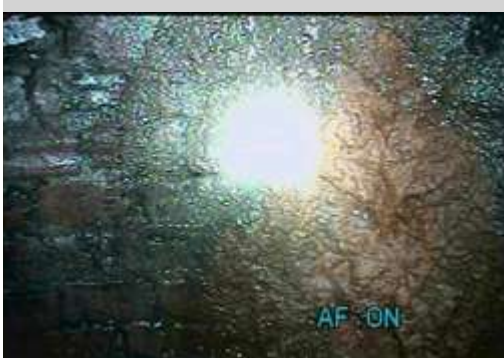
Defect 4

Infiltration: ☐ None ☐ Joint ☐ Cracks ☐ Mortar ☐ Roots ☒ **Wall**

infiltration in barrel

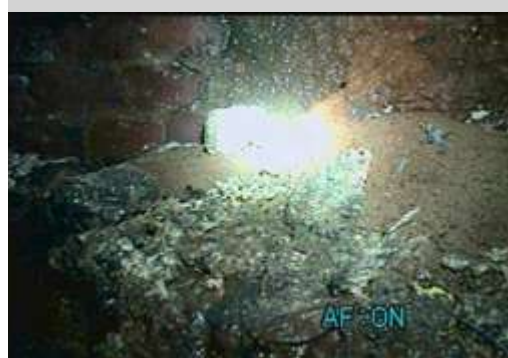
Defect 3

Condition: ☐ Sound ☐ Cracked ☐ Root Intrusion ☐ Deteriorated ☐ Leaks ☒ **Debris**

bench debris

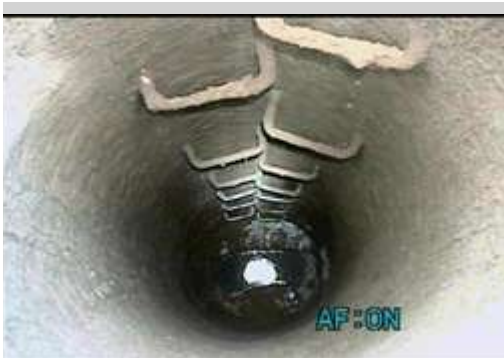
Defect 2

Steps Count: **13** Missing: **0** ☒ **Corroded**

steps

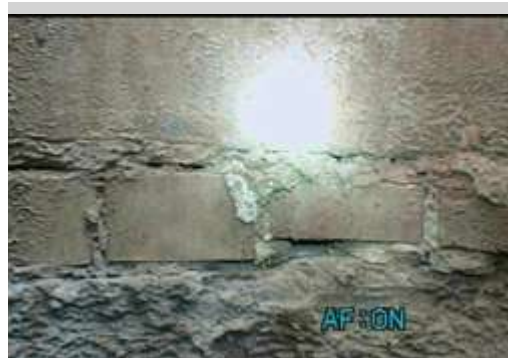
Defect 1

Condition: ☐ Sound ☒ **Cracked** ☐ Root Intrusion ☐ Loose Brick ☐ Deteriorated

chimney cracked, frame adj

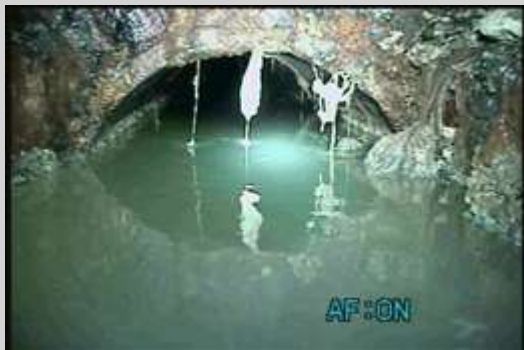
12 O'Clock Outflow

21 in. Circular Gravity Sewer
Pipe Out @ 12 O'Clock

Invert Depth: **20.75** (ft.) Flow Characteristics: **Fast**

Deposits: ☒ None ☐ Mud ☐ Sludge ☐ Debris ☐ Grease

Infiltration: **None** Pipe Seal Cond: **Unknown**

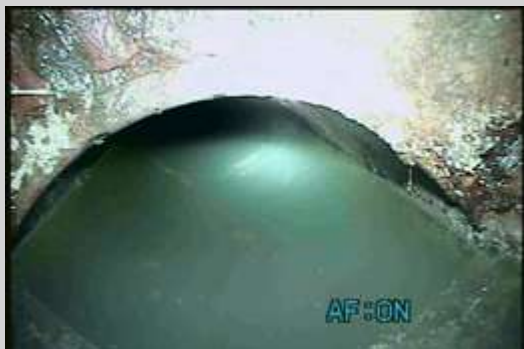
6 O'Clock Inflow

24 in. Circular Gravity Sewer
Pipe In @ 6 O'Clock

Invert Depth: **20.60** (ft.) Flow Characteristics: **Fast**

Deposits: ☒ None ☐ Mud ☐ Sludge ☐ Debris ☐ Grease

Infiltration: **None** Pipe Seal Cond: **Unknown**
